Manhole Inspection Summary

Manhole # S13S__009MH

Insp Date: **3/11/08 4:09 PM**

Location Address: **3001 Beson Ave** Cross Street: **Wilmington Ave**

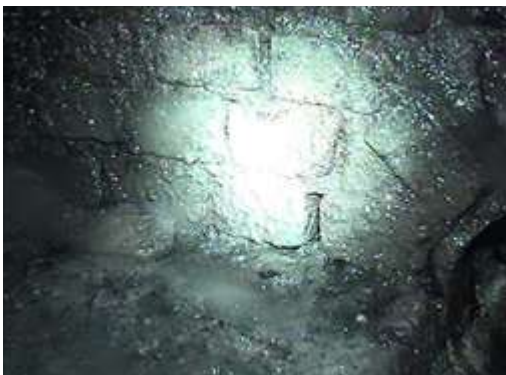
Defect 5

Condition: ☐ Sound ☐ Cracked ☐ Root Intrusion ☐ Loose Brick ☒ **Deteriorated**

barrel deteriorated mortar

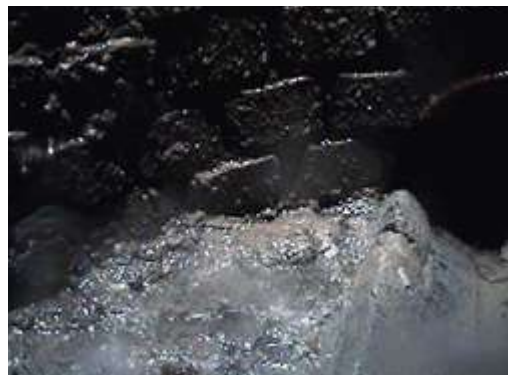
Defect 4

Infiltration: ☐ None ☐ Joint ☐ Cracks ☐ Mortar ☐ Roots ☒ **Wall**

barrel infiltration at wall

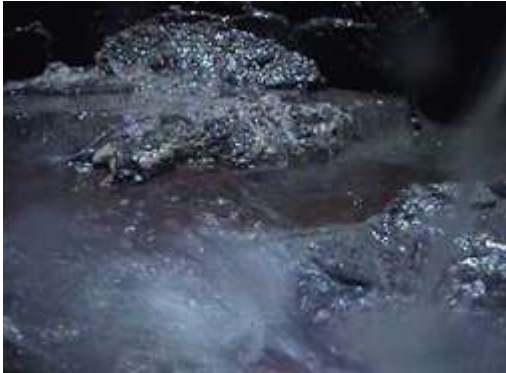
Defect 1

Condition: ☐ Sound ☐ Cracked ☐ Root Intrusion ☐ Deteriorated ☐ Leaks ☒ **Debris**

bench debris

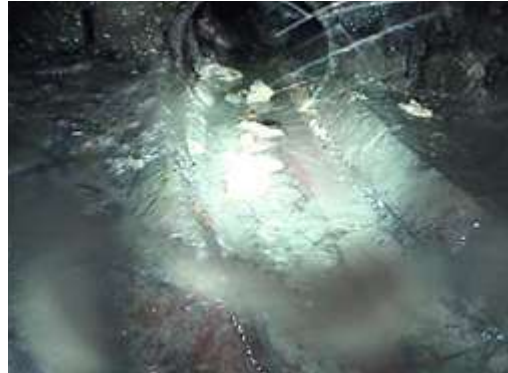
Defect 2

Condition: ☐ Sound ☐ Cracked ☐ Root Intrusion ☐ Deteriorated ☐ Leaks ☒ **Debris**

channel debris

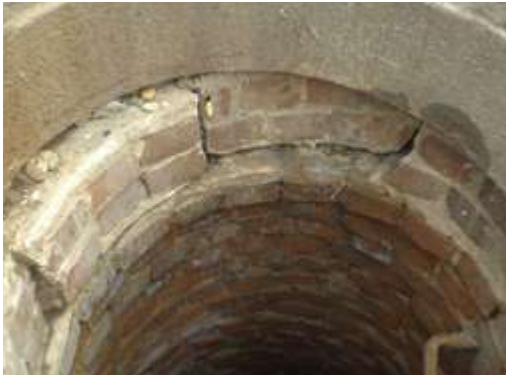
Defect 3

Condition: ☐ Sound ☒ **Cracked** ☐ Root Intrusion ☒ **Loose Brick** ☐ Deteriorated

Infiltration: ☐ None ☐ Joint ☒ **Cracks** ☐ Mortar ☐ Roots ☐ Wall

chimney cracked bricks, loose bricks, and gap at frame joint

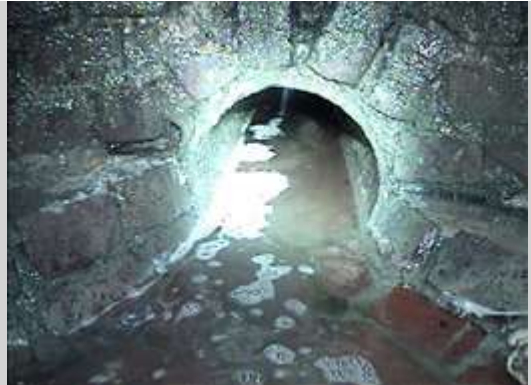
12 O'Clock Outflow

Pipe Height: **7.2** (in.) Rod and Bar (Angled)
Pipe Material: **Clay** ☐ Pipe Lined
Invert Depth: **11.52** (ft.) Flow Characteristics: **Slow**
Deposits: ☒ None ☐ Mud ☐ Sludge ☐ Debris ☐ Grease
Silt Depth: **0** (in.) Deposits Extent:
Infiltration: **Evidence** Pipe Seal Cond: **Unknown**

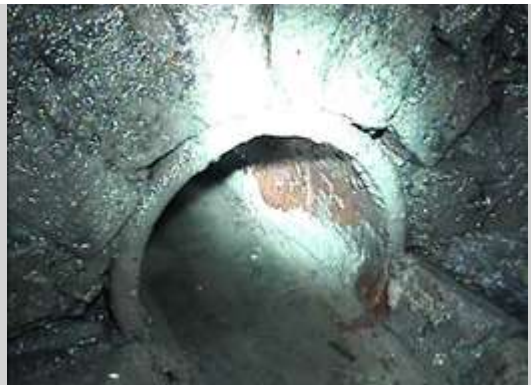
3 O'Clock Inflow

Pipe Height: **8.4** (in.) Rod and Bar (Angled)
Pipe Material: **Clay** ☐ Pipe Lined
Invert Depth: **11.50** (ft.) Flow Characteristics: **Slow**
Deposits: ☒ None ☐ Mud ☐ Sludge ☐ Debris ☐ Grease
Silt Depth: **0** (in.) Deposits Extent:
Infiltration: **Evidence** Pipe Seal Cond: **Unknown**

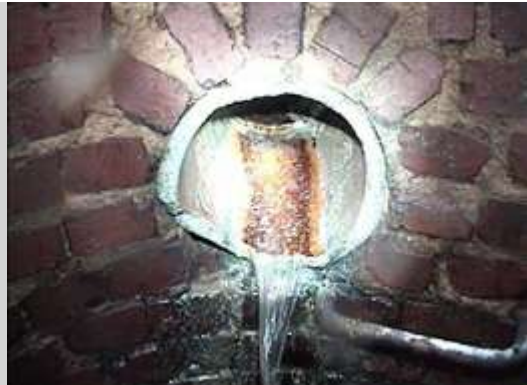
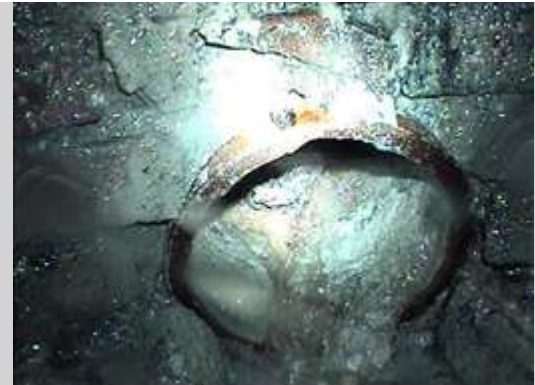
6 O'Clock Inflow

Infiltration: **Evidence** Pipe Seal Cond: **Unknown**

Drop: Inside	Rod and Bar
Angled: Yes	Reading: 10.44 (ft.)
	Inv Depth: 11.44 (ft.)
Drop Condition: Open

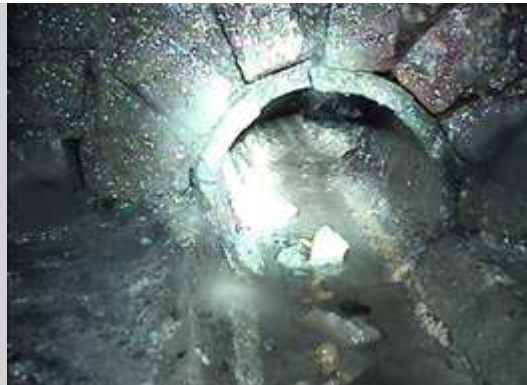
9 O'Clock Inflow

Infiltration: **Evidence** Pipe Seal Cond: **Unknown**
